**NBSIR 80-2134**

# **Fire Performance of Selected Residential Floor Constructions Under Room Burnout Conditions**

J. B. Fang

Interim Report

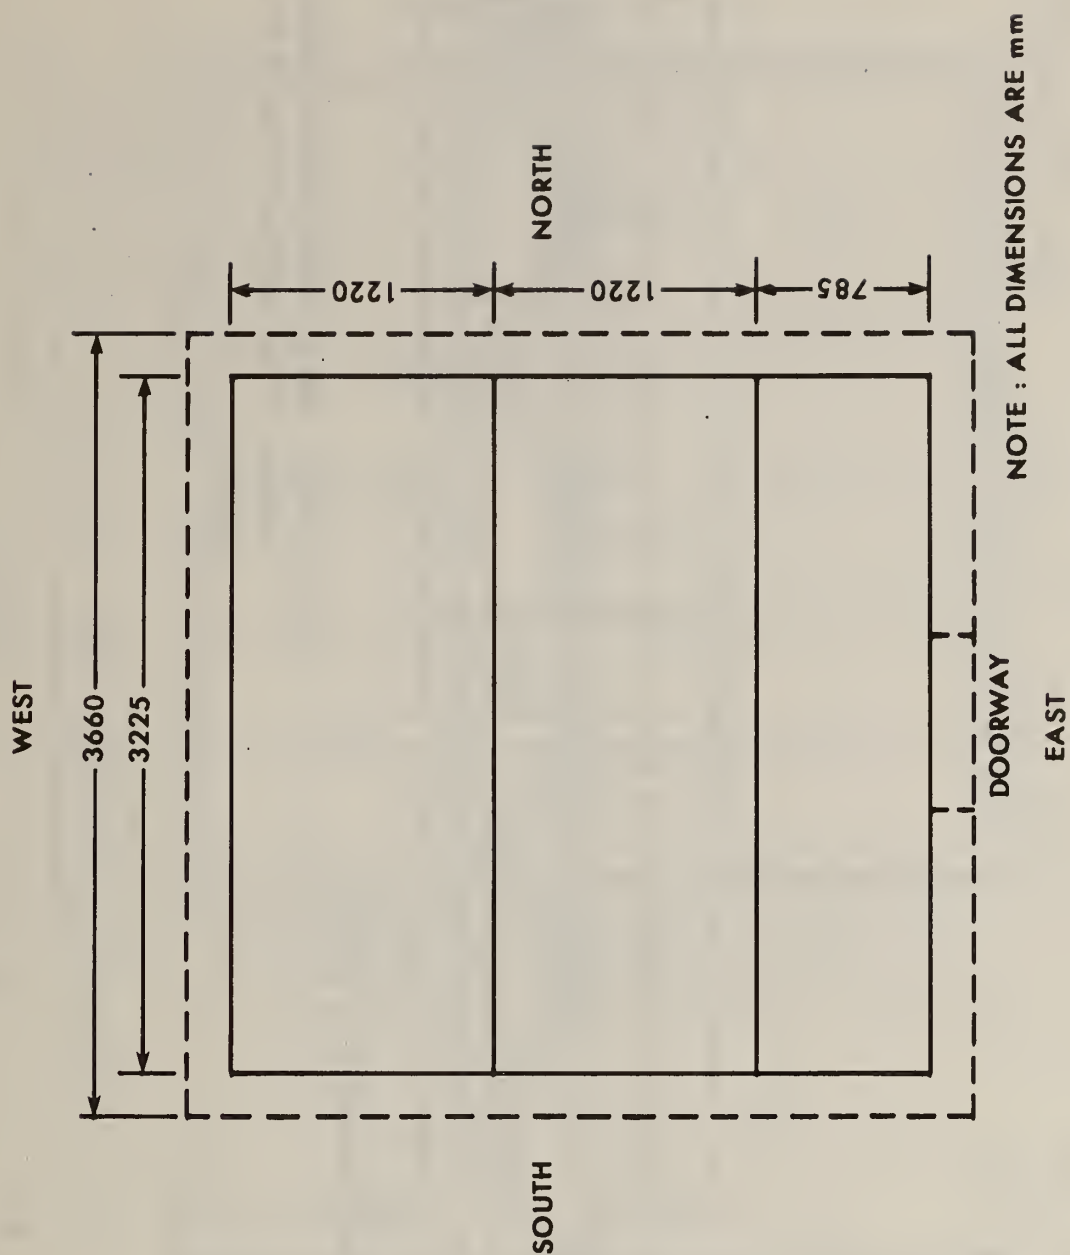
Figure 7. Floor Plan Showing Layout of Gypsum Board Ceiling for Tests 5 to 7.

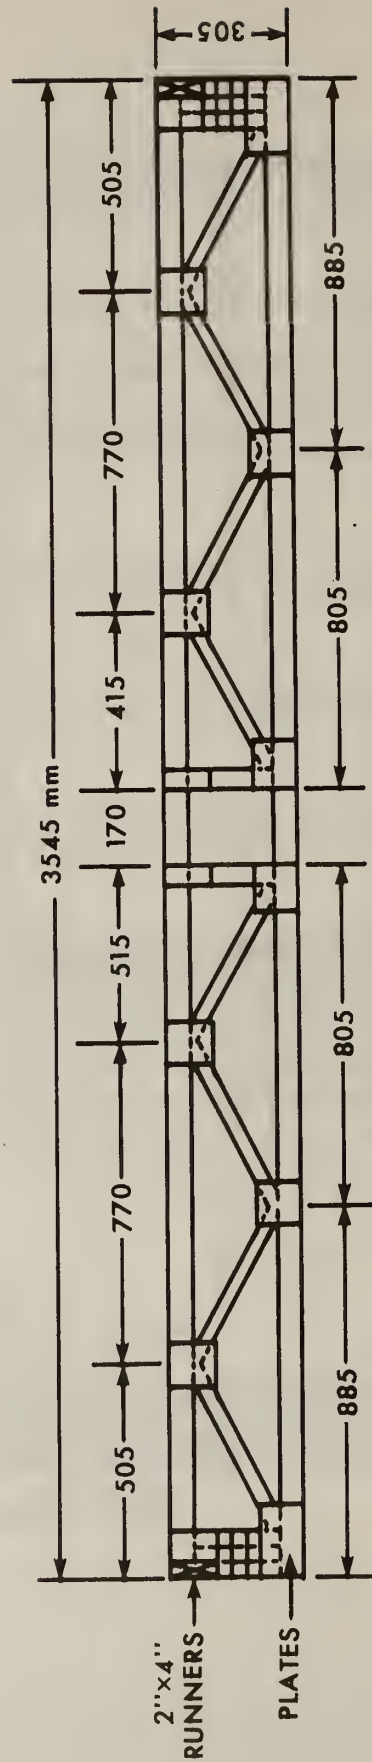
NOTE: PLATES - RONEL SERIES 5000 (20 GAUGE)  
LUMBER - TC, BC SOUTHERN PINE #2 2"x4" K.D.  
WEBS #3

Figure 8. Details of Wood Truss Construction for Test 6.

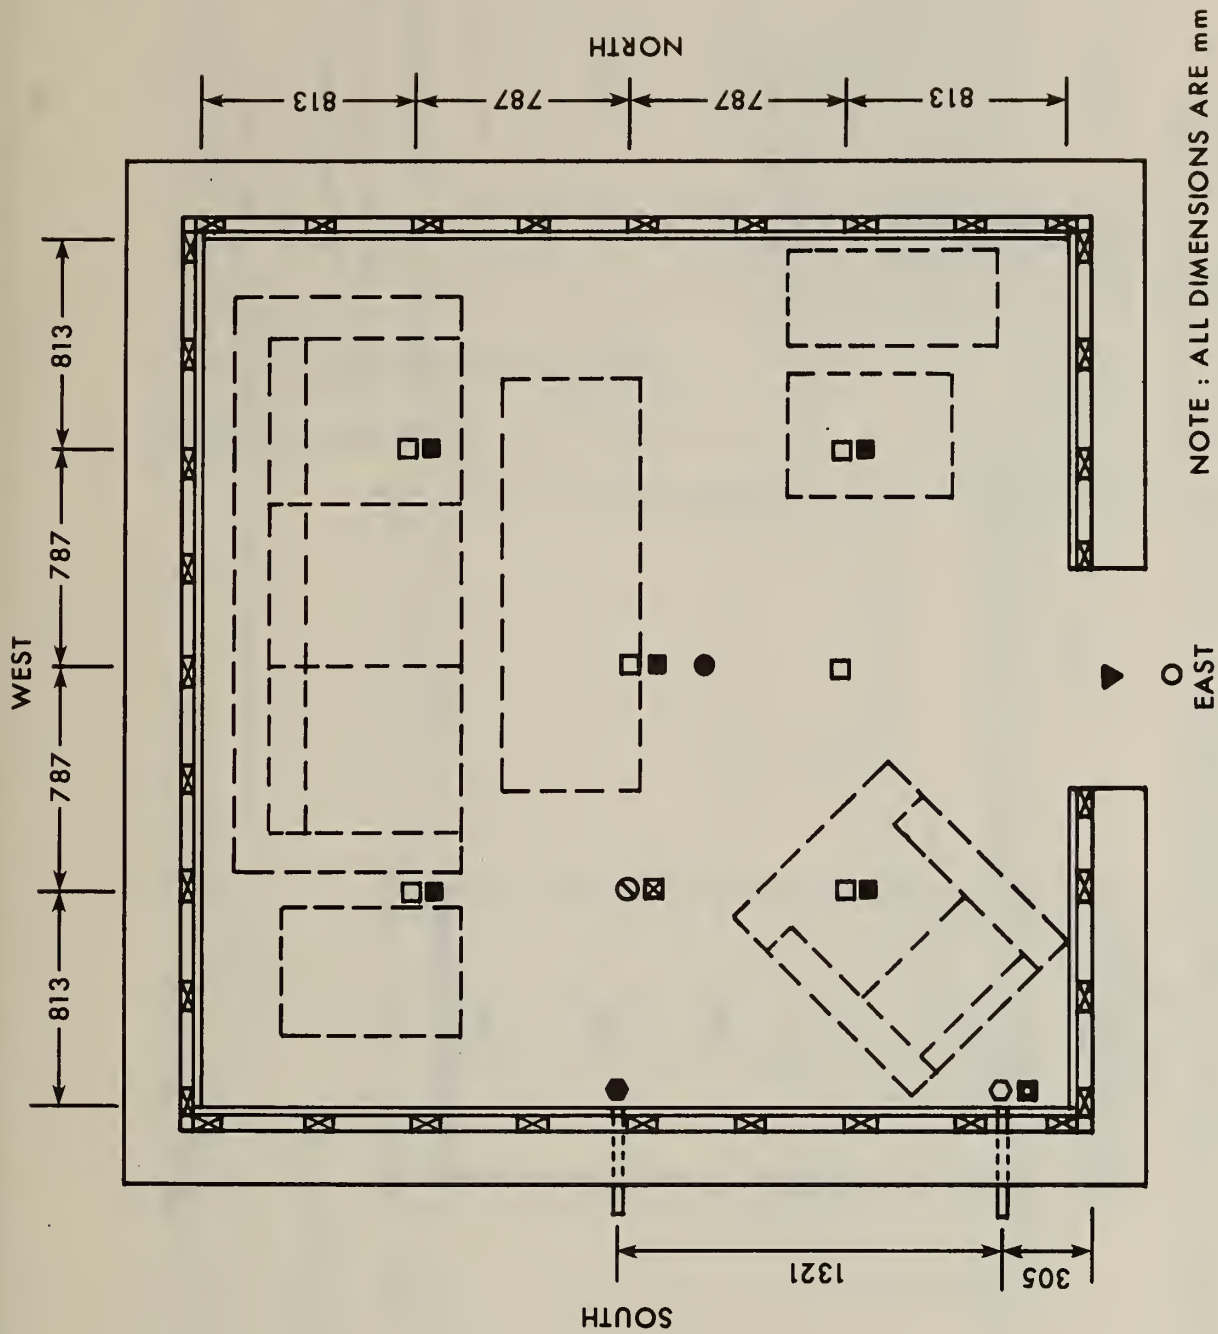
Figure 12. Plan View of the Test Room Showing Instrumentation Layout

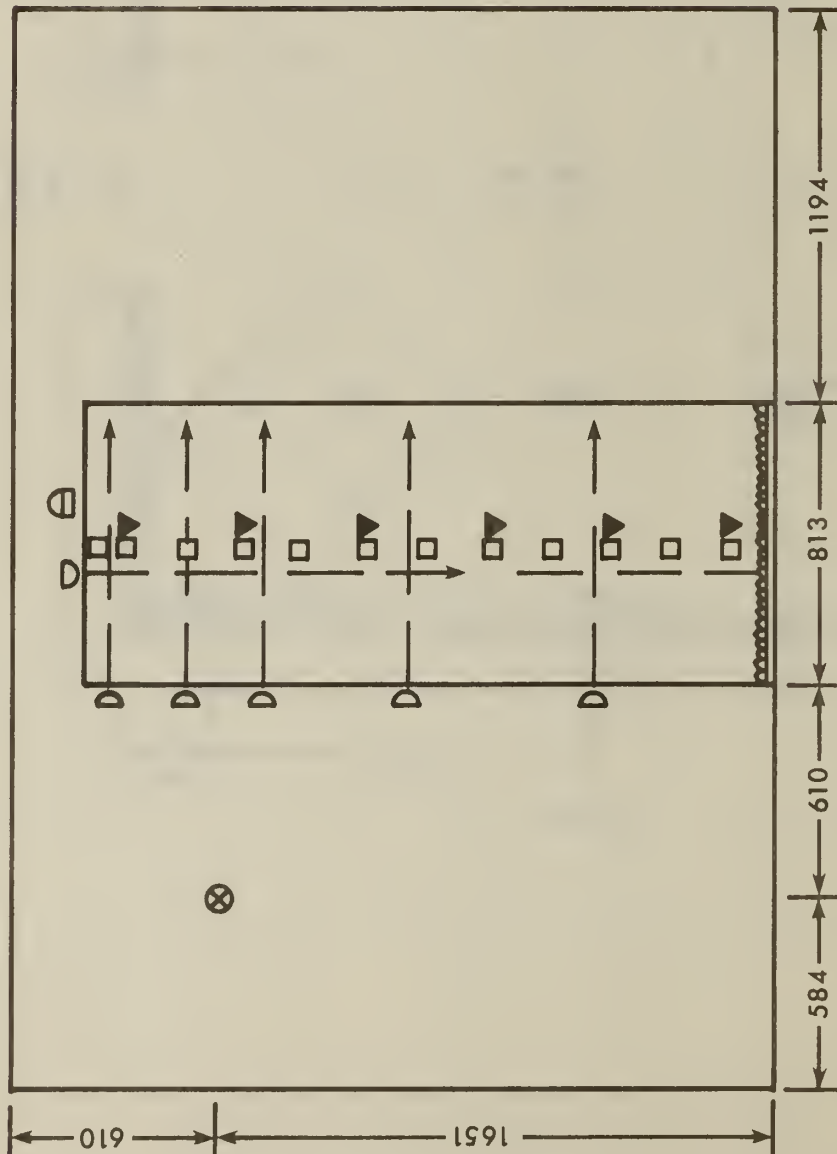
Figure 13. Instrumentation Layout at the Doorway Opening

The horizontal velocities of the air entering and leaving the fire room through the doorway opening were monitored with 6 bi-directional flow probes in conjunction with variable reluctance differential pressure transducers and carrier demodulators. These probes were installed normal to the plane of the opening along its vertical centerline and located at 0.13, 0.48, 0.84, 1.19, 1.55, and 1.91 m from the top of the doorway, as illustrated in figure 13.

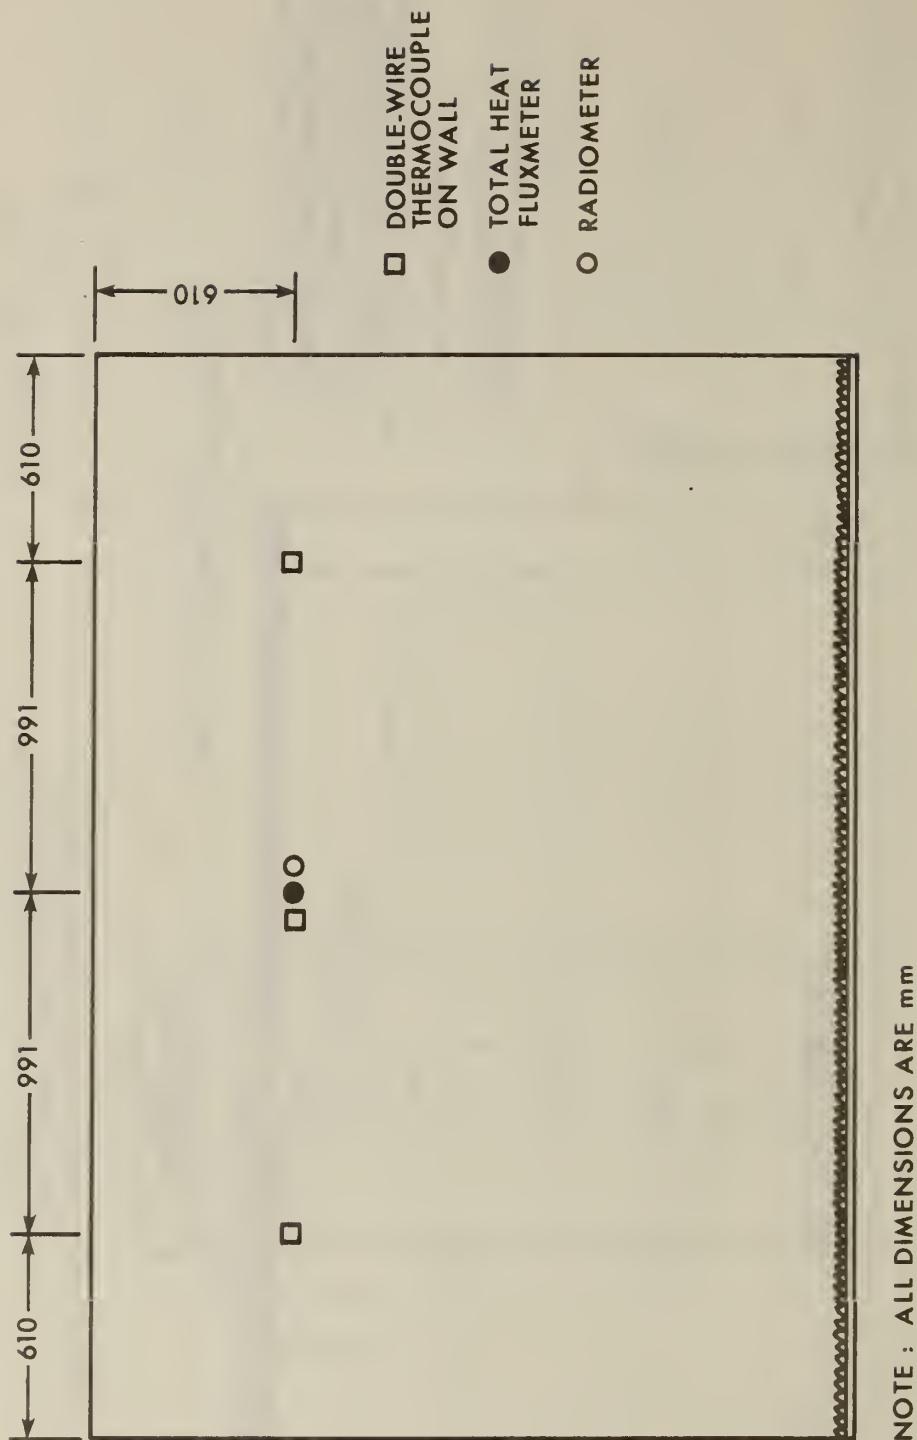
Figure 15. Instrumentation Layout-View of South Plywood Wall Showing Wall Thermocouples, Total Heat Flux Meter and Radiometer

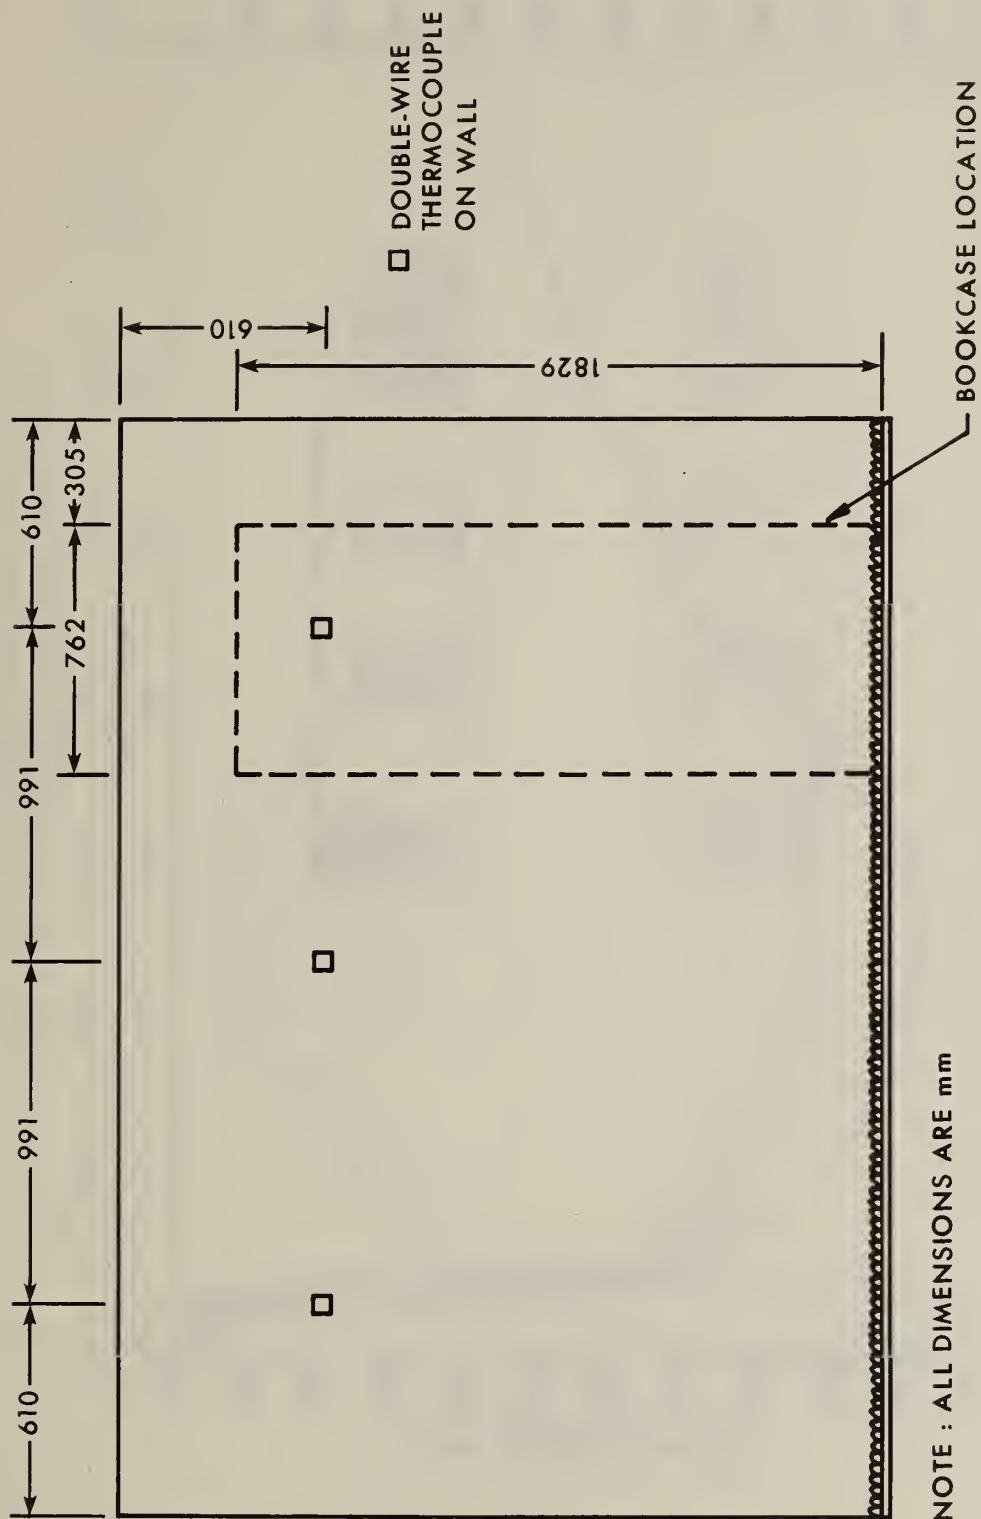
Figure 16. Instrumentation Layout-View of North Plywood Wall Showing Wall Thermocouples

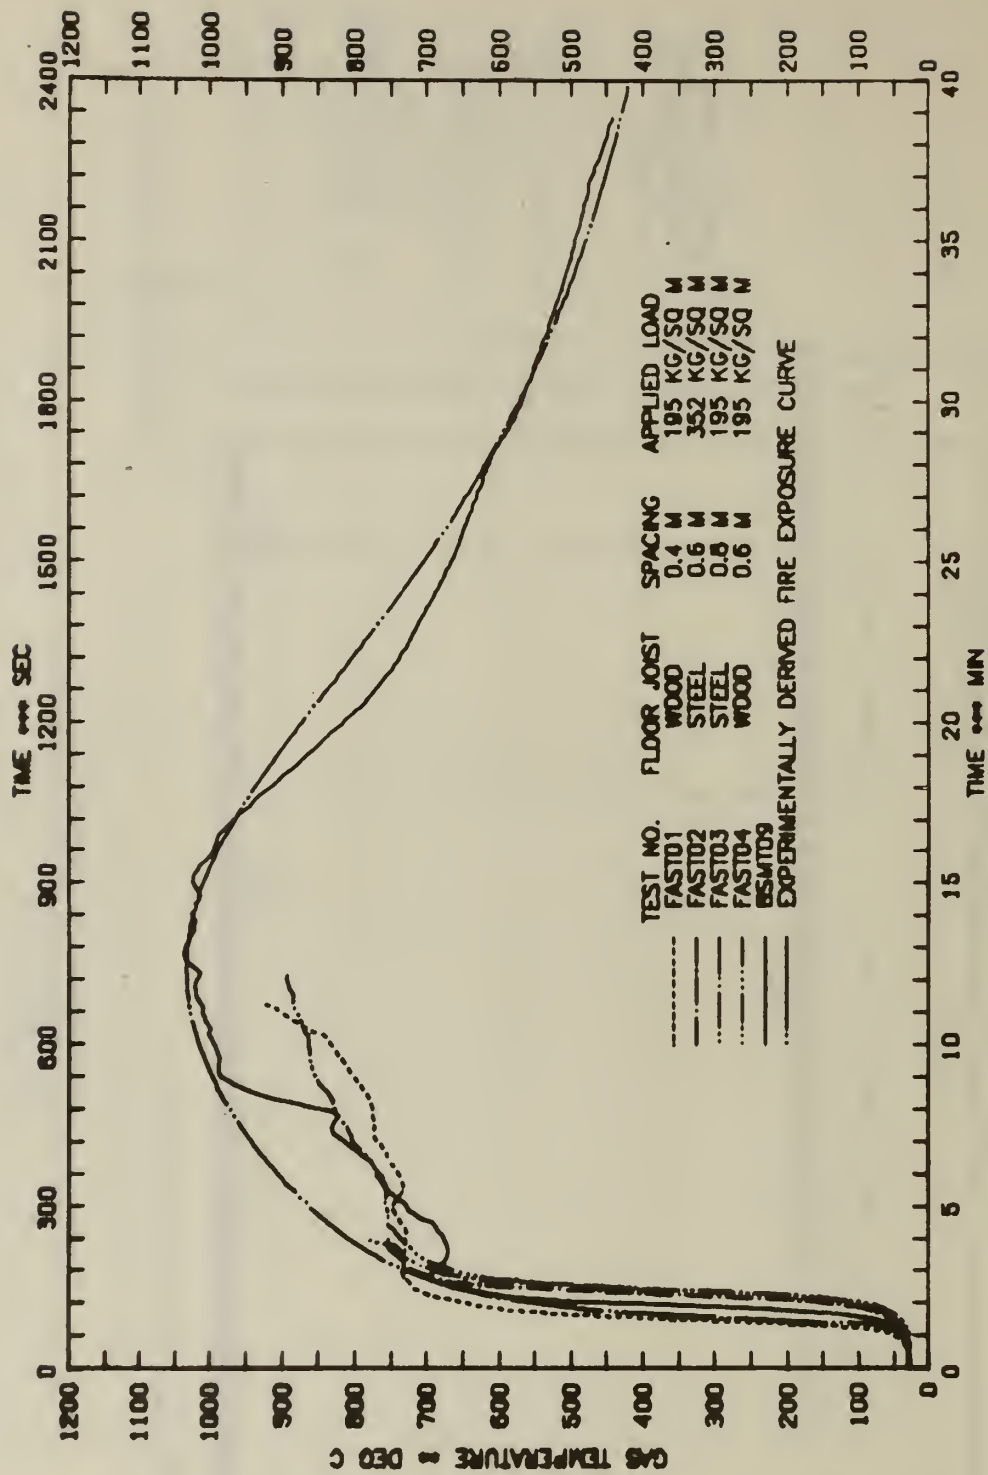
Figure 17. Comparison of Average Upper Room Gas Temperature for Tests 1 to 4 and Experimentally Derived Fire Exposure Curve

Time variations of the average gas temperature in the upper part of the fire room for all the tests conducted are shown in figures 17 and 18 along with the newly developed fire exposure curve. The derived fire exposure curve was obtained by approximating the experimental temperature versus time curve obtained in test 9 from a series of basement room fire tests [2] with a smooth curve. In this particular test, the 3.2 x 3.2 m burn room was finished with plywood paneling walls and gypsum board ceiling, and furnished with a typical loading of 23 kg/m<sup>2</sup> of domestic furniture. The newly developed

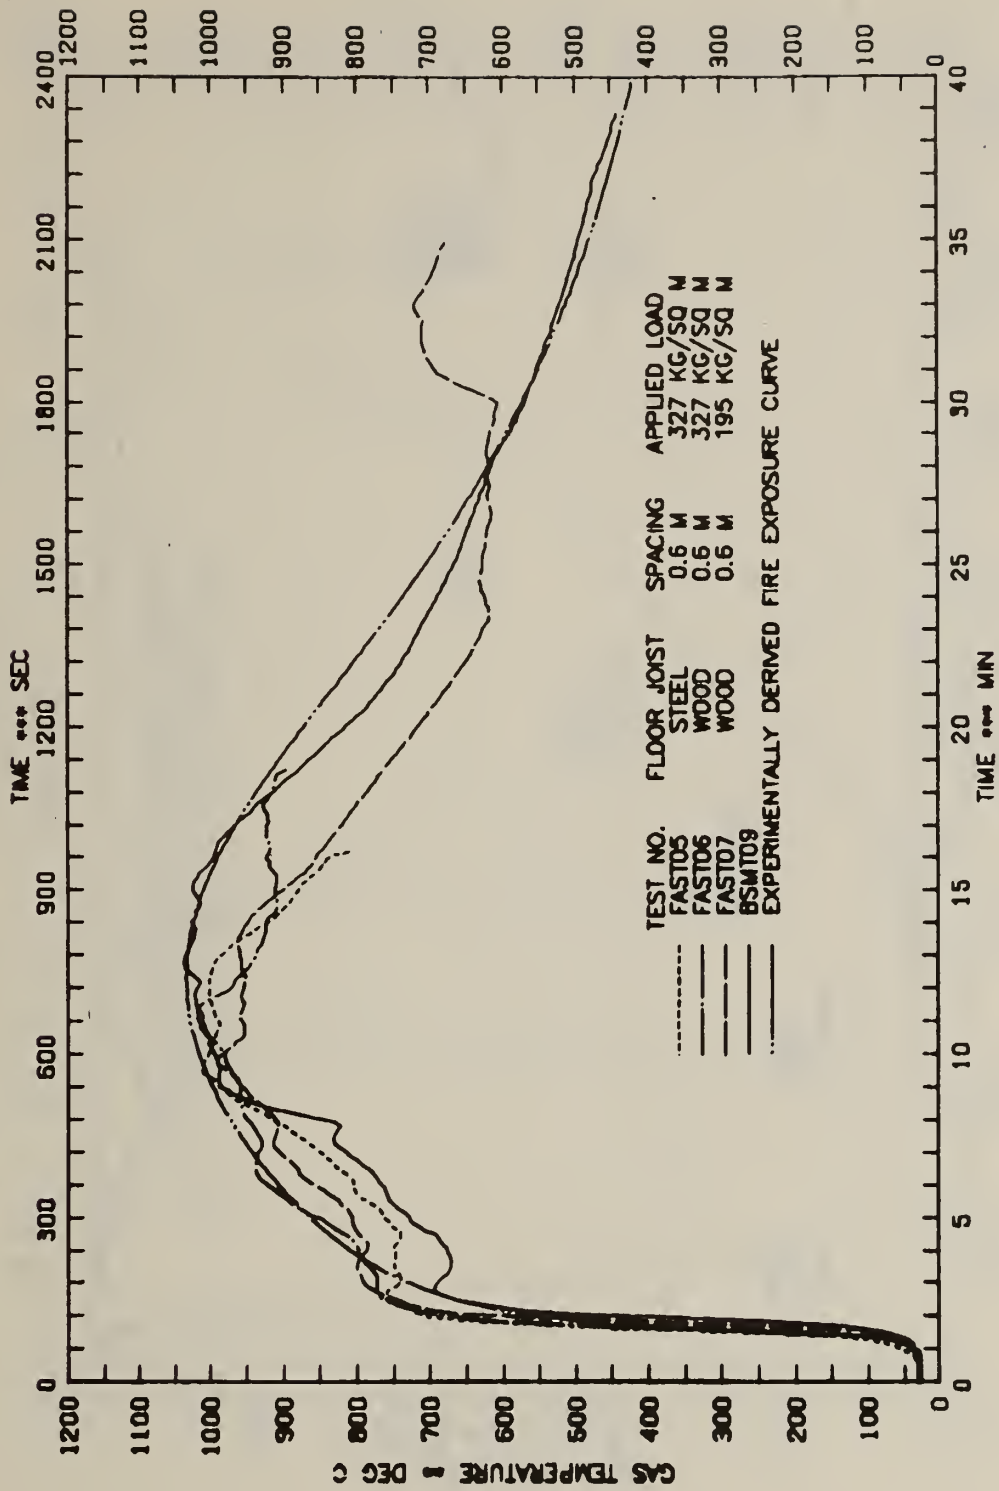
Figure 18. Comparison of Average Upper Room Gas Temperature for Tests 5 to 7 and Experimentally Derived Fire Exposure Curve

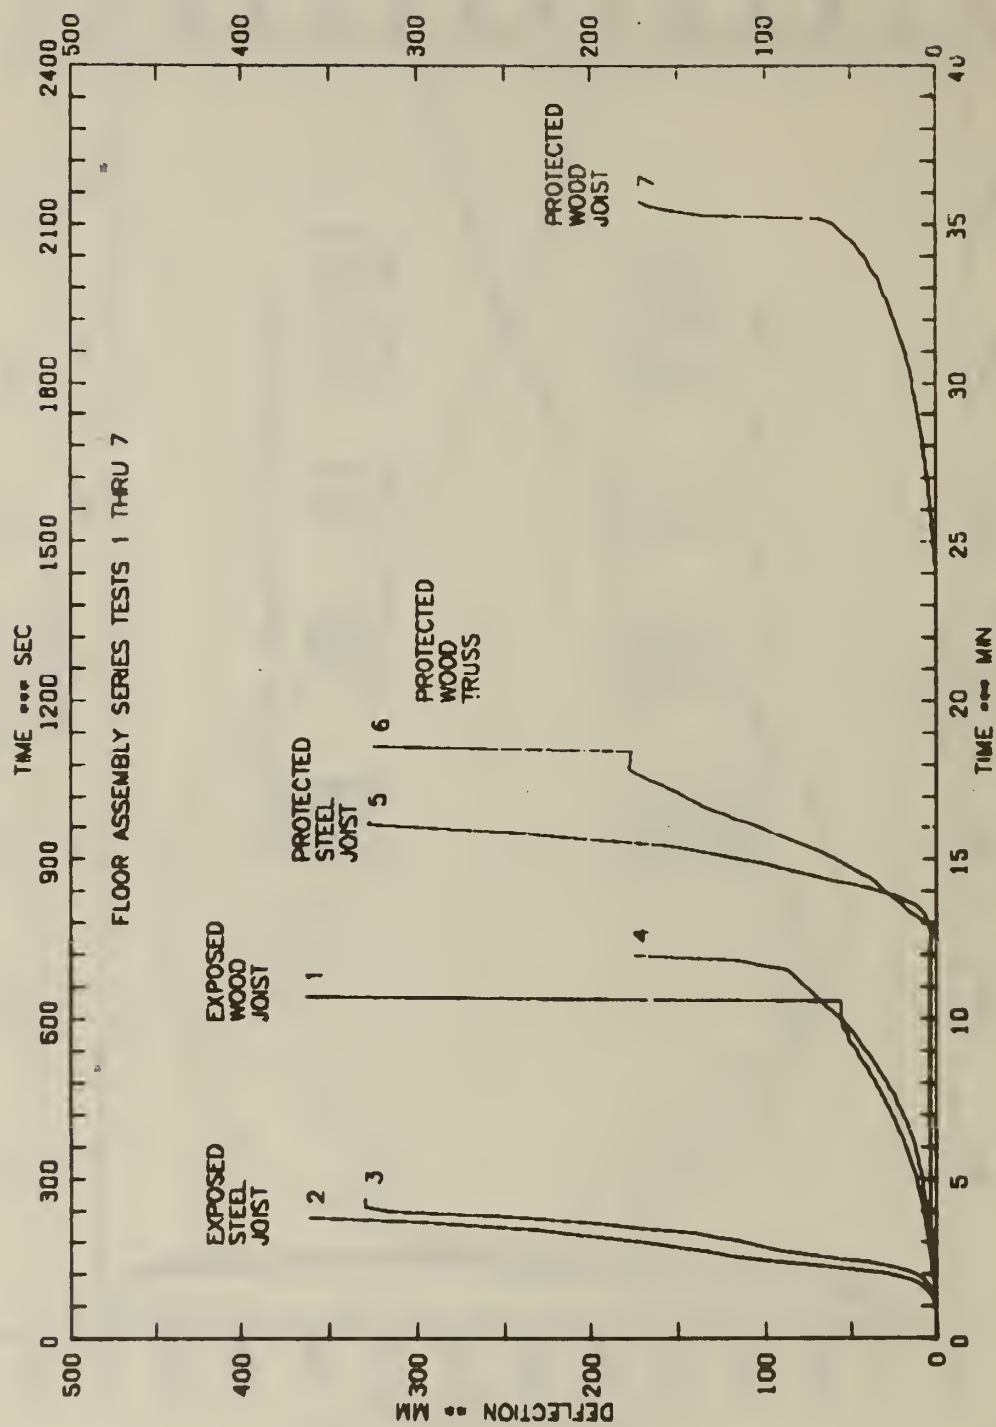
Figure 19. Floor Deflection Measured at the Center of the Test Assembly

The time variations of the floor deflections measured at the center of the test assembly for individual tests are shown in figure 19. As shown, the steel framed floors (tests 2, 3, and 5) had similar deflection curves where the deflection became significant only near the time of structural

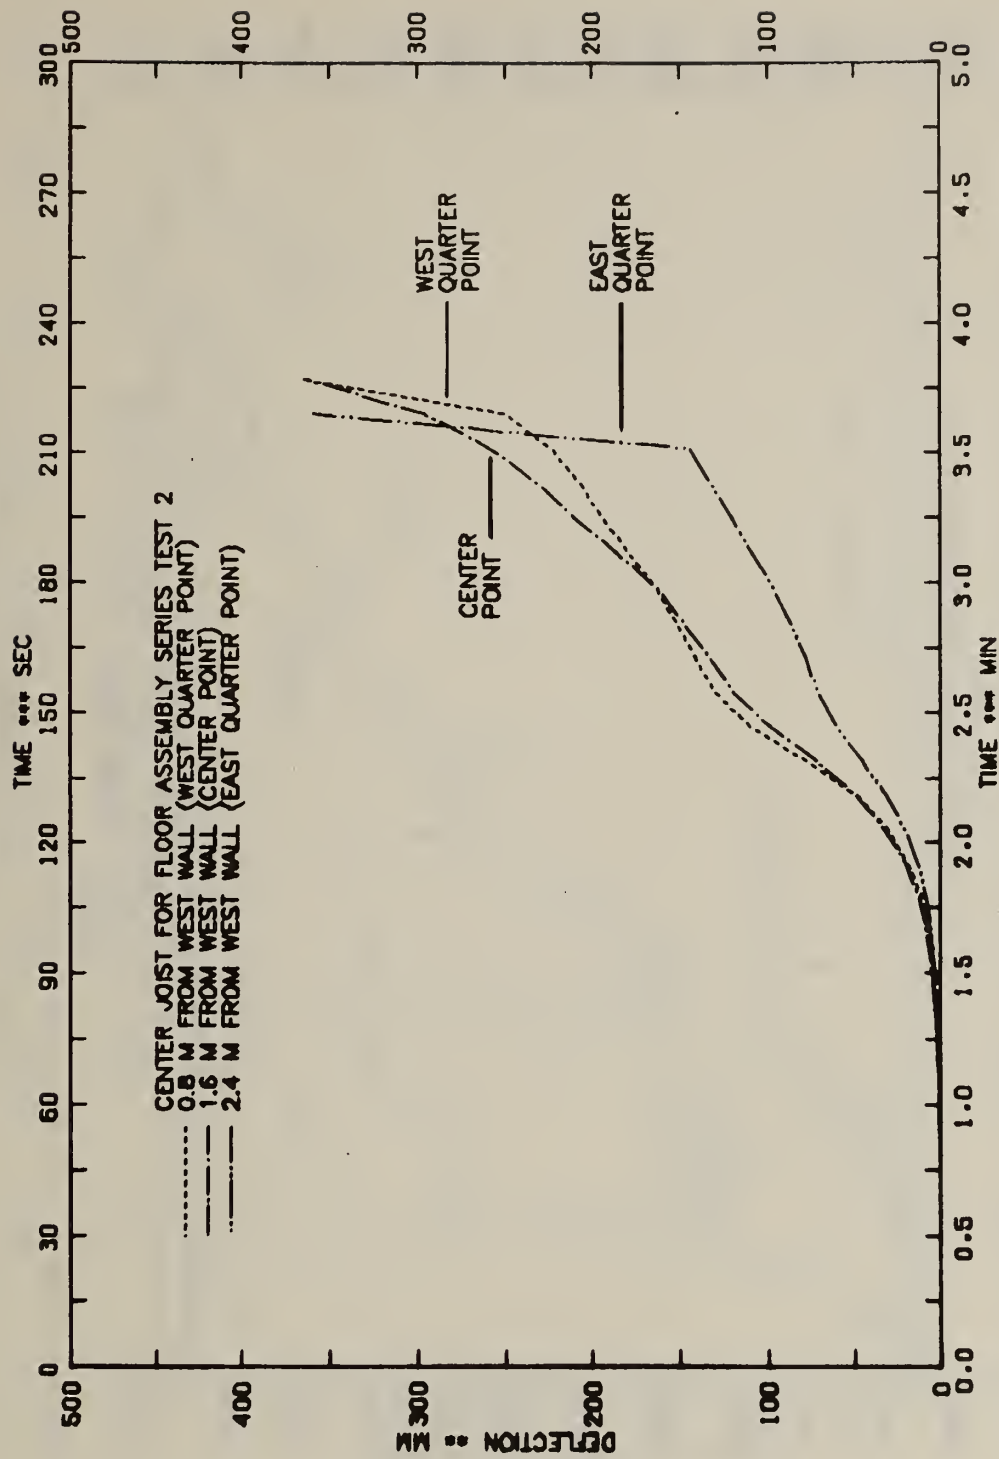
Figure 20. Floor Deflections at Center and Quarter Points Along the Center Joist at Various Times for Test 2

Figure 20 illustrates the floor deflections at the center and the quarter points along the centrally located joist at various times for test 2. It can be seen from the figure that the rates of deflections at the center and the west quarter point increased more rapidly than that at the east quarter point, although the temperature differences in the room at these locations were less than 60°C. The temperatures developed in the steel joist at the sections of both quarter points were found to be approximately the same, but the deflection was substantially different, especially at times of imminent collapse of the joist. The reason for this wide variation in deflection during the course of the fire is not known. (Note that the west quarter point was over the sofa where the exposure might be greater for the first 4 minutes.)

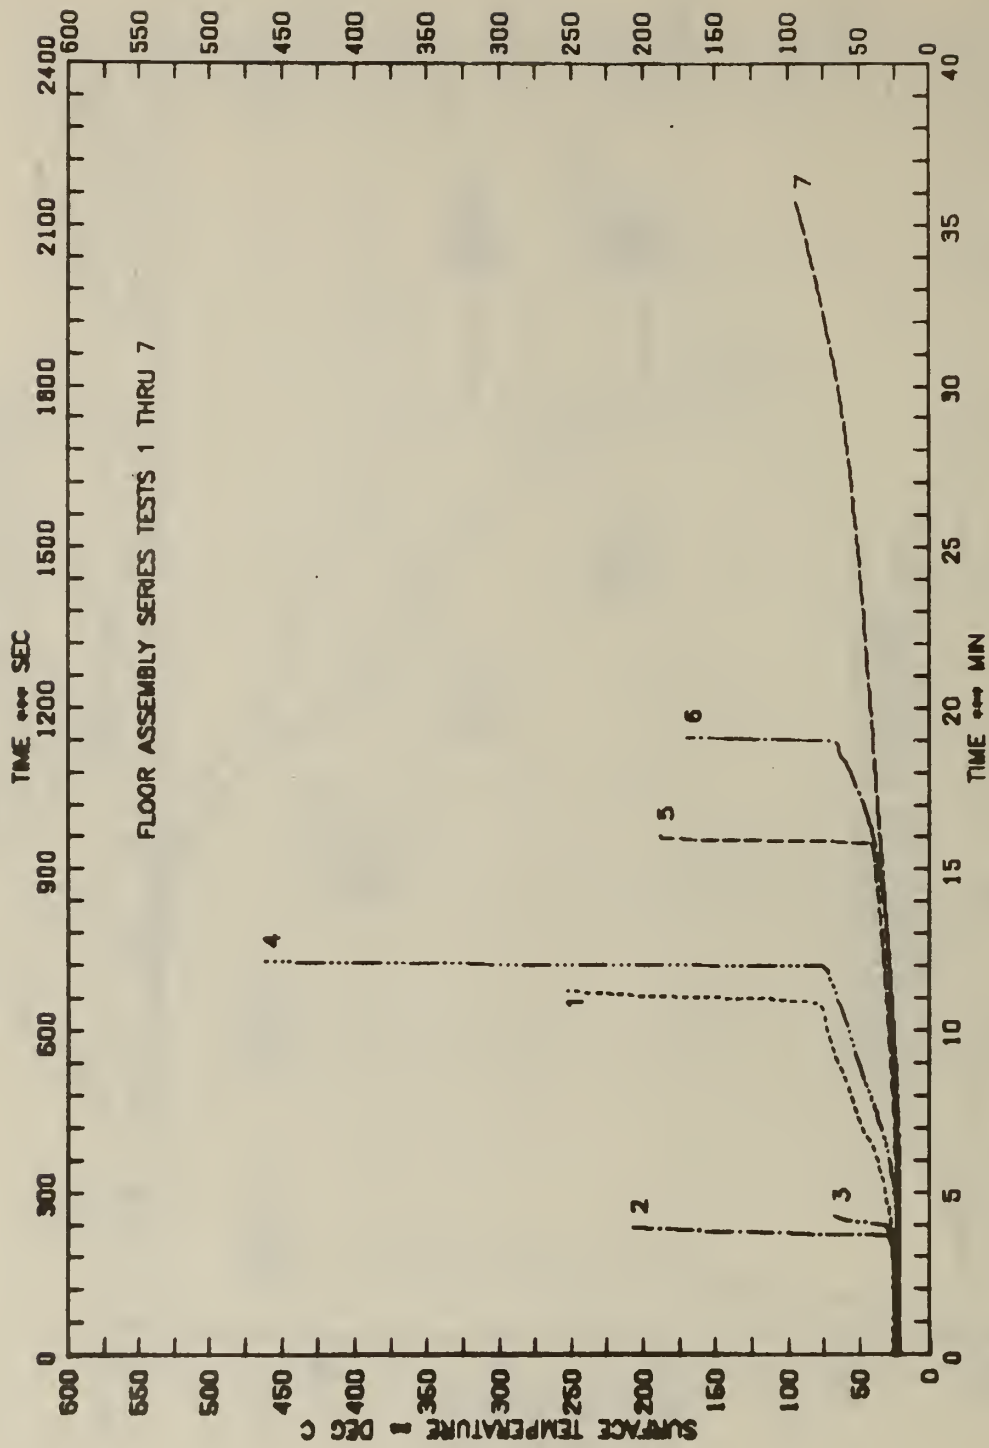
Figure 21. Time Variations of Average Surface Temperatures on the Unexposed Side of Test Assembly for all Tests Performed

The average surface temperatures on the unexposed side of the floor-ceiling assembly as a function of time for all the tests performed are shown in figure 21. These average temperatures were derived from averaging the readings of 10 thermocouples attached on the carpet surface, including 9 equally spaced thermocouples and one located 1.52 m from the south edge and 0.76 m from the west end of the assembly. As would be expected, the unprotected assemblies (tests 1 to 4) had a faster rise in surface temperature than the floor systems with a fire protective ceiling (tests 5 to 7). In the tests conducted, the average temperature increases of greater than 139°C above the initial temperature on the unexposed surface were not observed before failure by passage of flames through the assembly. As shown, the protective ceiling delayed the time of temperature failure by approximately 12 minutes for 13 mm gypsum board and more than 23 minutes for 16 mm type X gypsum wallboard.

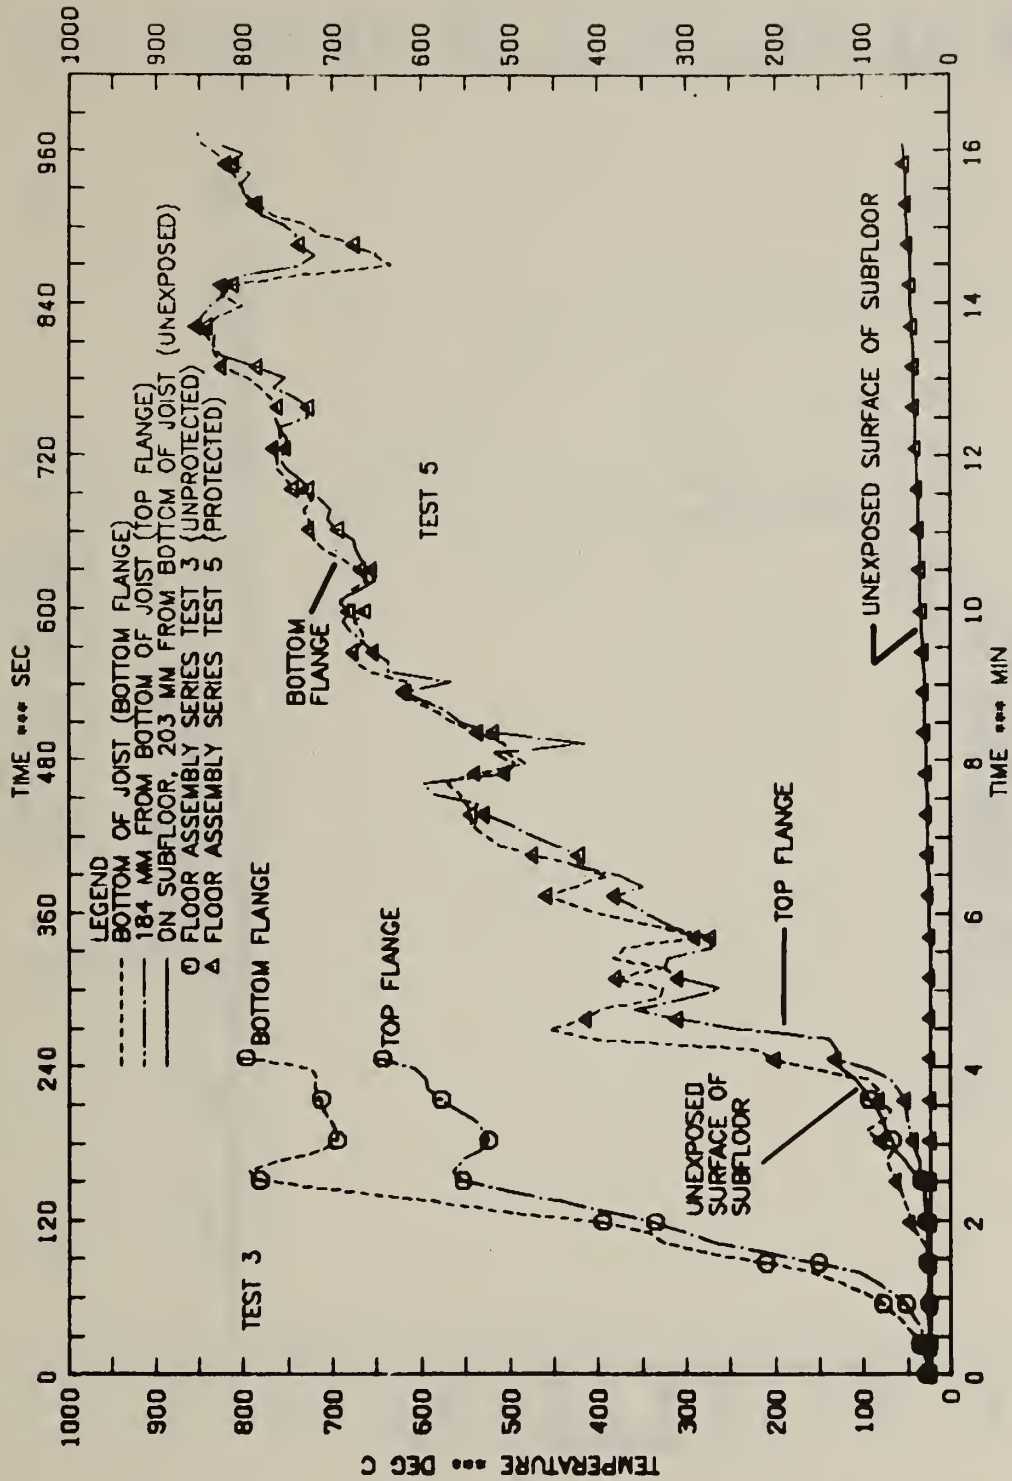
Figure 22. Comparison of Surface Temperature of Steel Joist and Plywood Subfloor for Assemblies With and Without a Protective Ceiling

A comparison of the surface temperatures attained at the top and bottom of the steel joist and that at the top of the plywood subfloor located above the center of the room for the tests with and without a protective ceiling (tests 5 and 3) is shown in figure 22. As shown, the temperature in the top flange of the floor joist was consistently lower than that in its bottom surface. This was due to the fact that there was continuous conduction of heat away from the top surface to the cooler plywood subfloor, and for the

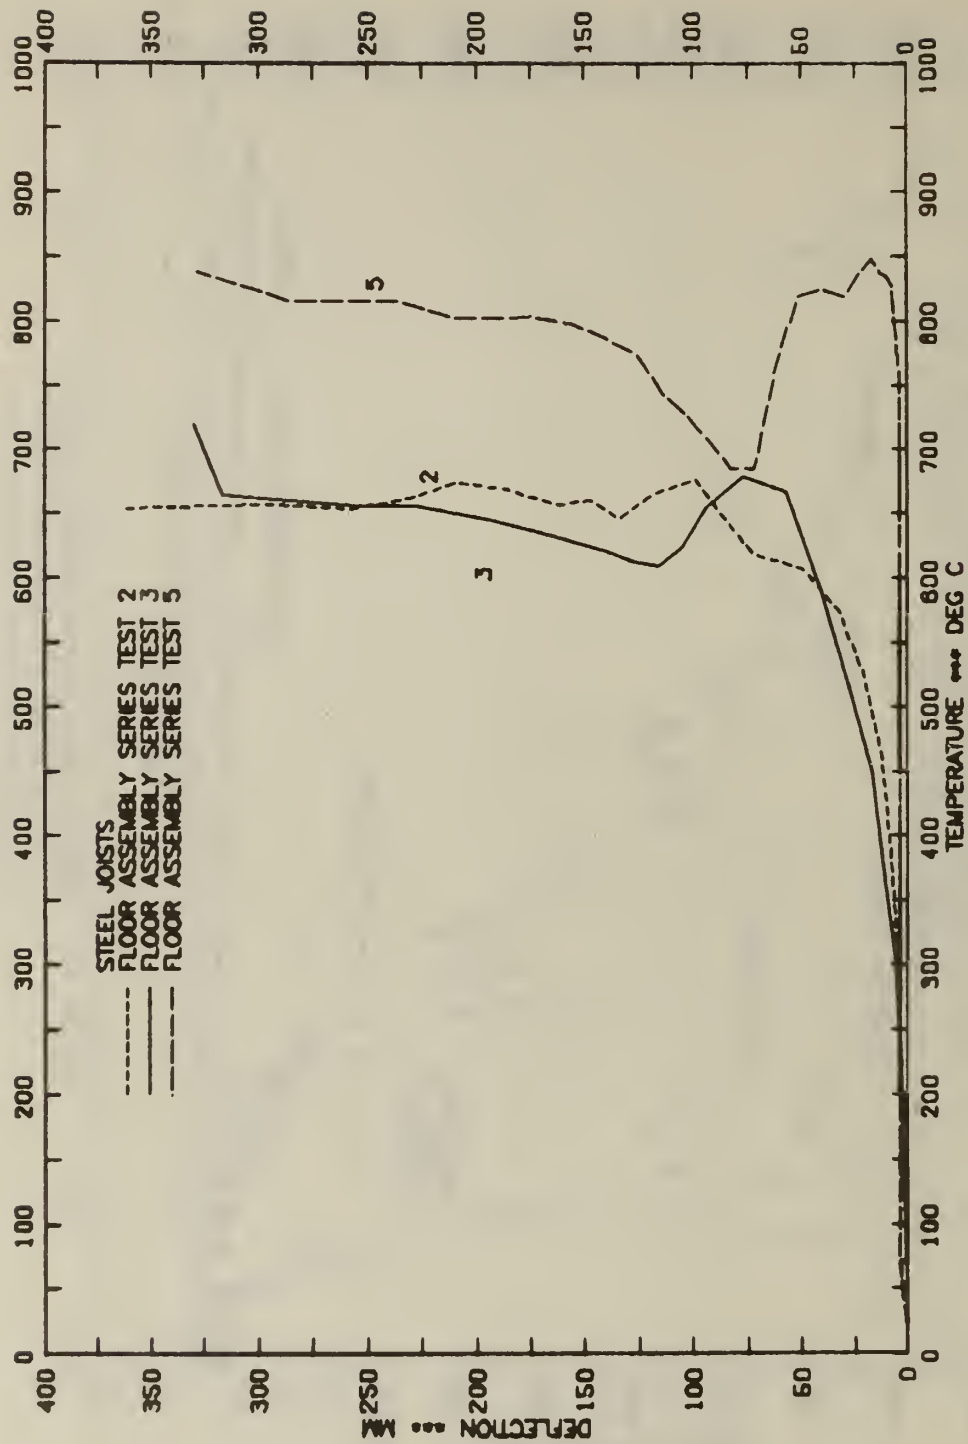
Figure 23. Relationship Between Floor Deflection and Steel Joist Temperature at Center of Test Assembly

Figure 23 shows a plot illustrating the relationship between the measured floor deflection at the center of the test assembly and the corresponding average temperature of the centrally located steel joist at the same instance for tests 2, 3, and 5. The steel temperature was obtained by averaging the readings of the two thermocouples attached to the top and bottom of one cross section along the longitudinal centerline of the test assembly. As shown in the figure, the deformation of the steel joist became greater as the average temperature of the structural element increased with fire development. Rapid deflection of the assembly occurred and the floor joist failed to support the applied load when the joist reached a temperature level of approximately 650°C for the unprotected floor assembly and 820°C for the floor with a fire protective ceiling. These steel temperatures were higher than the permissible temperature of 593°C for steel structural elements [1]. There was a considerable fall in the steel temperature when the floor deflection was approximately 80 mm in test 5. This was probably due to the decrease in local air temperatures resulting from the dilution of the heated air surrounding the joist by the gaseous pyrolysis products from the decomposing plywood subfloor. A similar plot of floor deflection versus the average of the surface temperatures measured at the top and bottom of the cross-section located at the middle of the center joist involving wood framed floors for tests 1, 4, and 7 is given in figure 24. As shown, significant deflection was not perceived until the average exterior temperatures of wood joists attained a temperature level ranging between 650 and 750°C. The failure of wooden structural elements was as a result of the reduction in cross sectional area due to charring and burning during the fires. The charred and burned areas were estimated to vary from approximately 53 to 75 percent original cross sectional area for these tests. With the decrease in cross sectional area, the shear and bending stresses increased and the joist failed when these stresses exceeded its yield point.

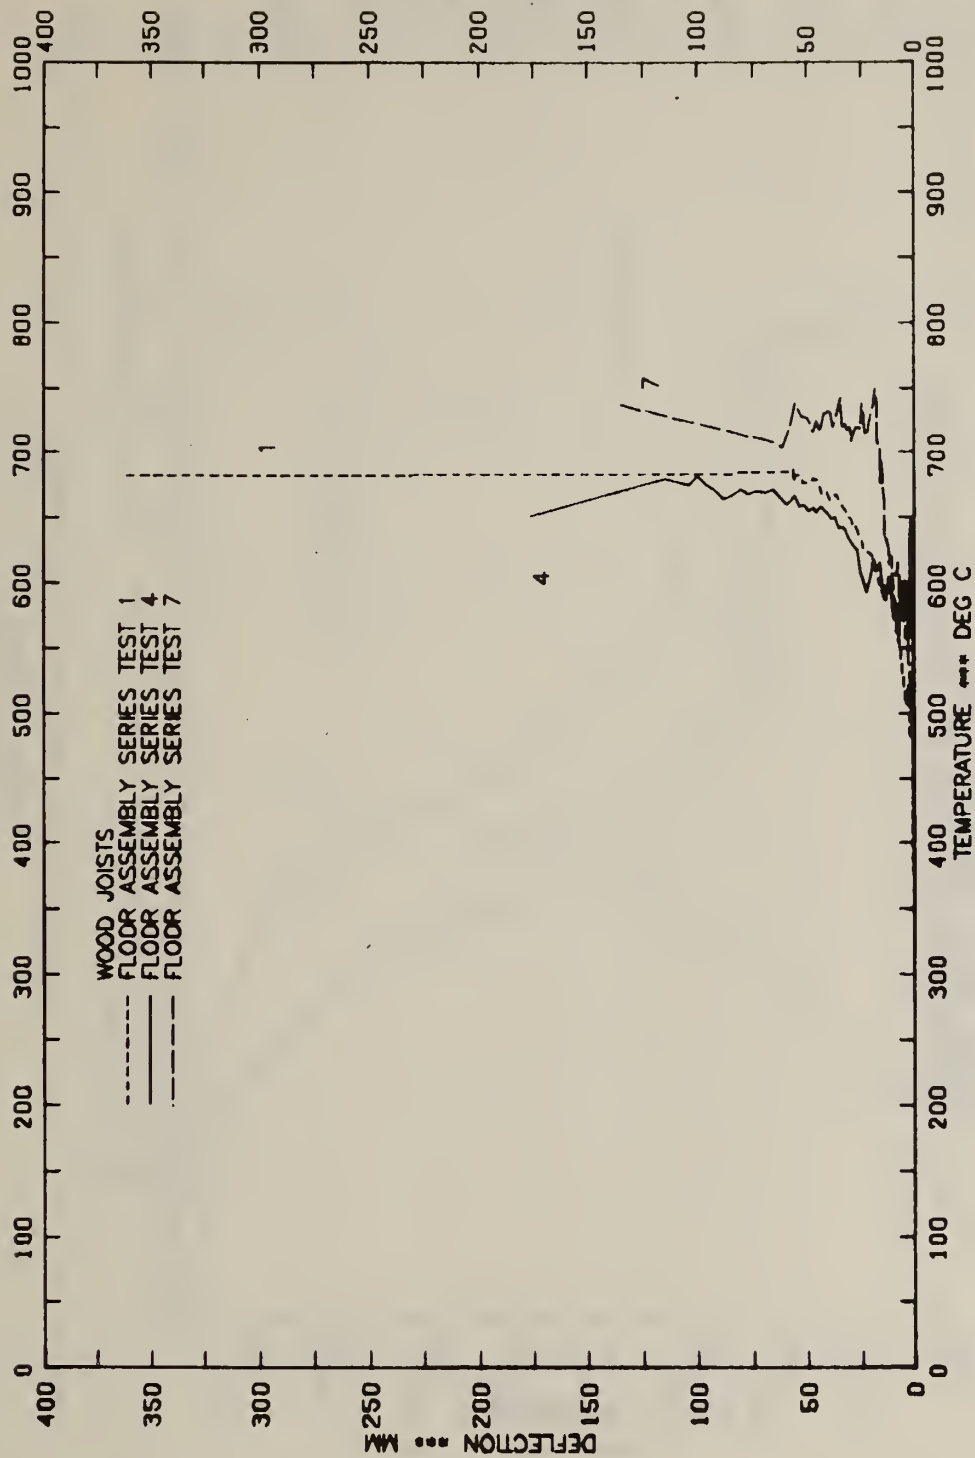
Figure 24. Relationship Between Floor Deflection and Wood Joist Temperature at Center of Test Assembly

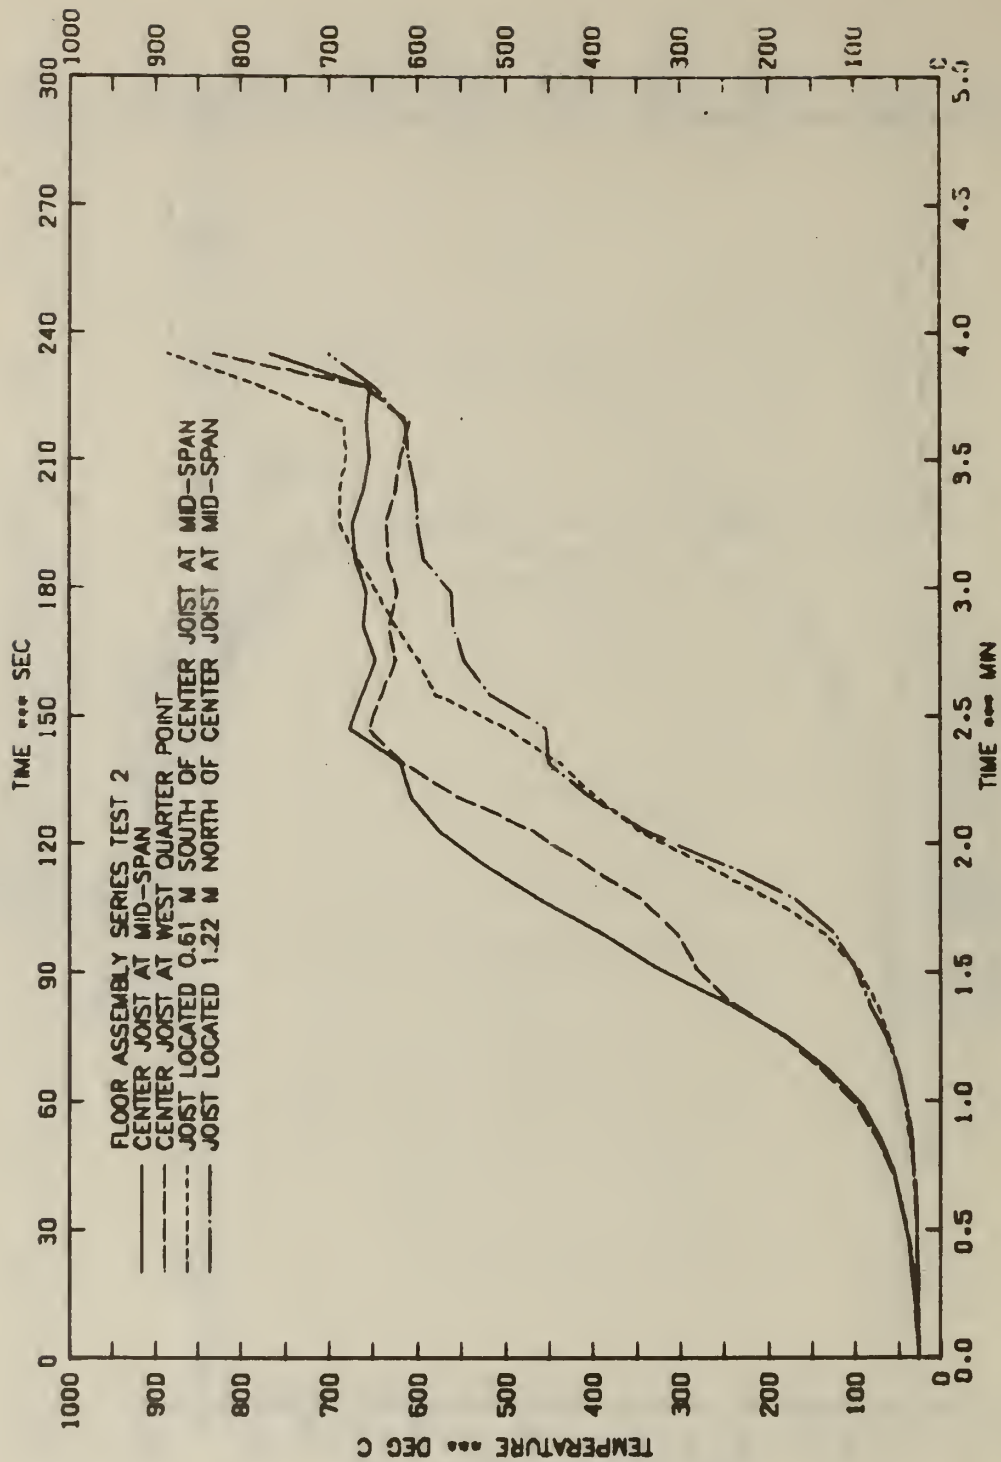
Figure 25. Time Variation of Average Temperature of Steel Joists at Various Locations

The time variations of the steel temperatures derived from averaging the values of surface temperatures measured at the top and bottom of the cross sections situated at various locations are shown in figure 25. It can be noted that the temperatures developed at two locations in the center joist increased more rapidly prior to room flashover than those in the other two neighboring joists due to earlier and direct exposure to the developing fire. However, this temperature difference attributed to relative locations of floor joists involved with the fire reduced with time after flashover.
